Compendium on Pavement Maintenance and Rehabilitation Practices

REAAA Technical Report TC-13

REAAA Project: QA of Pavement Structures

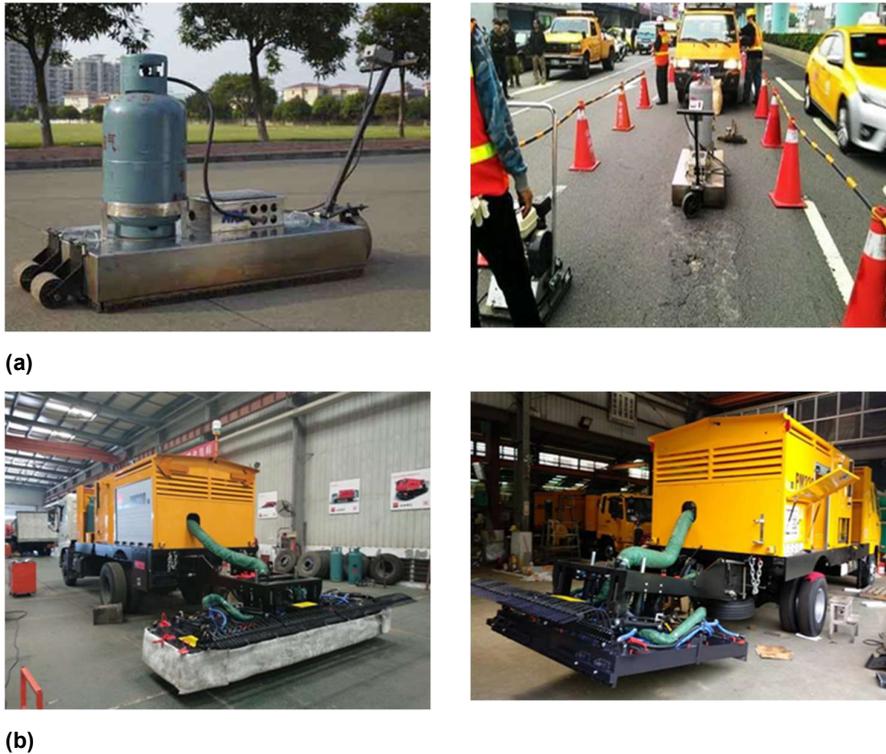
Figure 1: Hot-in-place recycling patching technology:
(a) Hand-push hot-in-place recycling patching machine; (b) Hot-in-place recycling repair unit

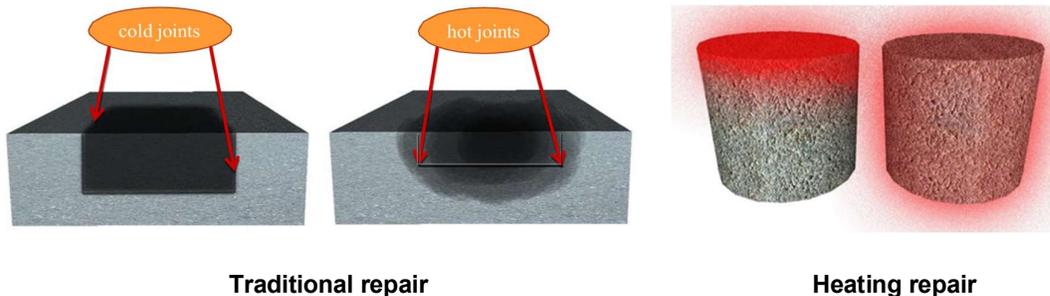
If directly heated by the flame from above, the surface will become overheated and the asphalt surface layer will be damaged due to aging (Figure 2, left). However, if intermittent radiant heating is used, the surface of the pavement can be evenly heated (Figure 2, right).

Figure 2: Advantages of hot-in-place recycling patching technology:
(a) evenly heated by intermittent radiant heating; (b) cold joints can be avoided

- Good repair effects and strong water resistance: the repaired area and the surrounding area are heated at the same temperature to avoid cold joints and repair gaps, as shown in Figure 2.

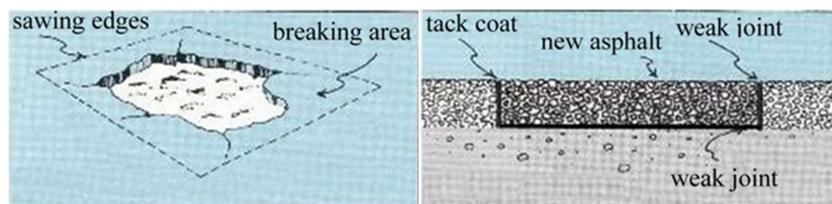
In traditional saw-break-fill methods such as pothole repair, the technique of breaking the original pavement around the pothole after square cutting is often used, as shown in Figure 3. The process involves:

- drawing a cutting line on the pavement around the pothole
- using a hydraulic pick hammer to break the surface materials
- removing the scrap materials and cleaning the repaired area
- spraying a tack coat
- filling the hole with new asphalt
- manual levelling and compaction.

The sides and lower layer of the broken pavement and the new asphalt will be bonded together using a tack coat. However, the sides and lower surface of the pavement are at room temperature, and the new hot asphalt will cool and shrink after contact. Therefore, it is easy for weak interfaces and gaps to form. Rainwater can then infiltrate into the asphalt, causing fall-off, with the potential for the pothole to reappear.

Figure 3: Traditional pothole repair method

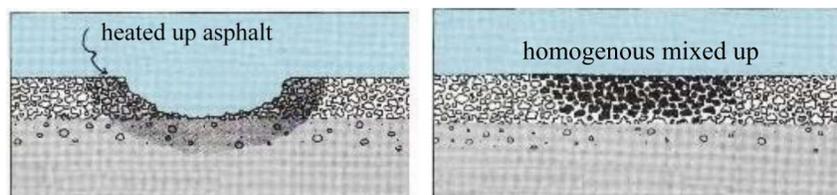
While hot-in-place recycling patching technology for pothole repair involves sawing and breaking-free, heat is used to soften the asphalt on the road surface while retaining and using the original asphalt. As a result, the asphalt on the original side and lower surface is also hot. When laying new hot asphalt, both the new and original asphalt are at a high temperature that is close to each other, resulting in a good thermal bonding effect being achieved, and the asphalt is fused together in a manner similar to welding. This reduces the generation of weak interfaces and gaps, and the strength can be improved. Like a newly-paved road, it is difficult for the pothole to reform, as shown in Figure 4.

Figure 4: Hot-in-place recycling patching technology for pothole repair

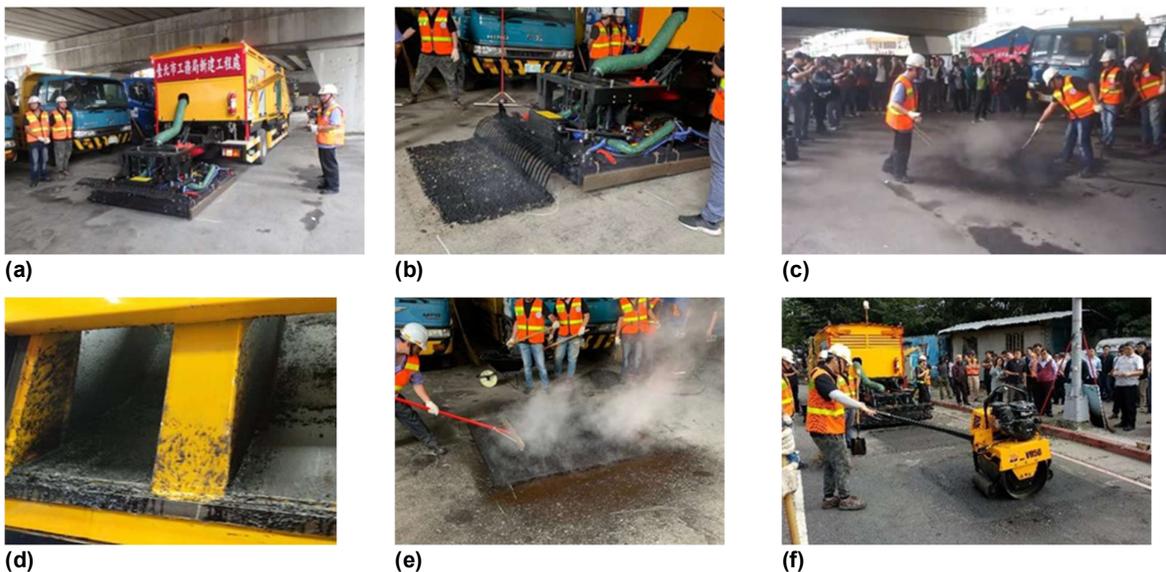
The hot-in-place recycling repair construction process using the PM220 is shown in Figure 5(a) to (f), whilst the self-check form for hot-in-place recycling patching projects is provided in the Appendix. The process is as follows:

- Drive the repair vehicle to the damaged location, start the power supply and hydraulic system, and lower the transformable heating panel onto heat the road surface.
- After softening the asphalt on the surface, close the transformable heating panel, lay down the iron rake, and start the self-propelled iron rake to scarify the road surface.
- Spray emulsified asphalt.
- Open the dual hoppers with the heating and keeping functions and fetch new asphalt mix.
- Add new asphalt mix to the road surface.
- After manual levelling, use a VR50 single-drum vibratory roller to compact the repaired road surface.

Figure 5: Hot-in-place recycling repair unit PM220 in operation

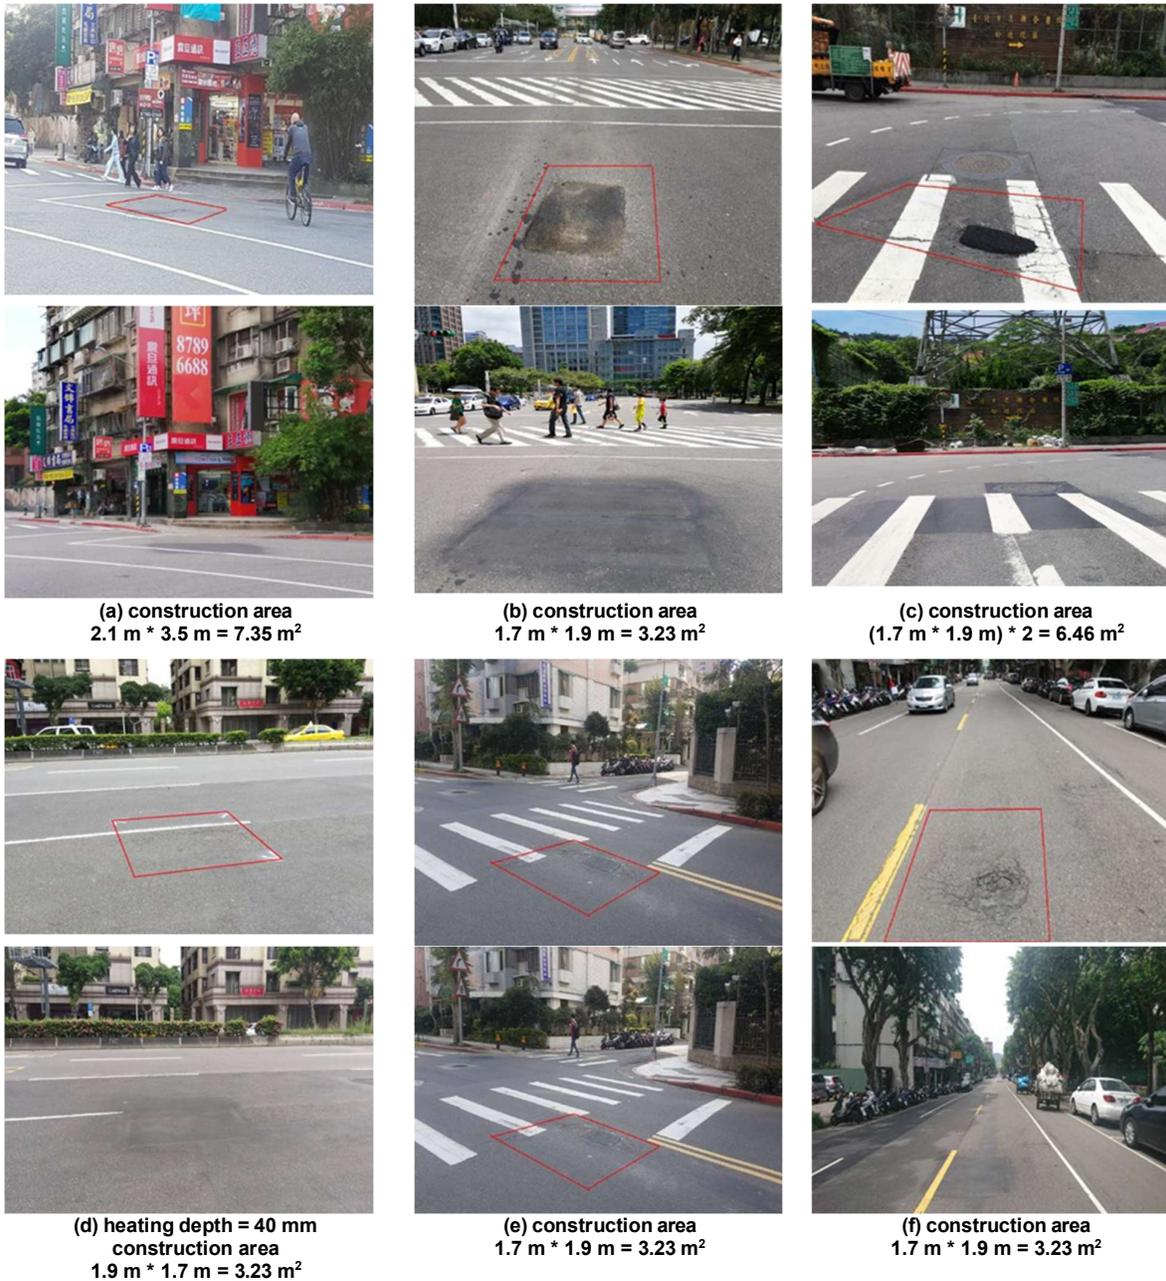
Hot-in-place recycling patching technology has been widely used on urban roads in Taipei City since it was introduced by the Taipei City Government in 2016. Examples of the use of the technology in Taipei City in recent years, which demonstrate the practical achievements of the method, are shown in Figure 6.

Figure 6: Case studies of hot-in-place recycling patching technology application in Taipei City

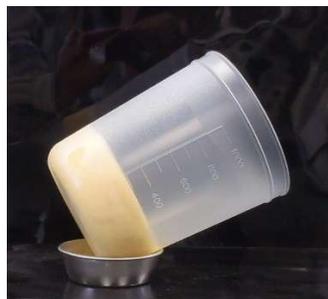
In order to improve the workability and durability of the moisture-hardened mix, the physical properties of more than ten types of fatty acid were investigated. It was found that the fatty acid used by the authors in an earlier study had a high viscosity at low temperatures and was likely to harden (Figure 2).

Figure 2: High-viscosity fatty acid (-10°C)

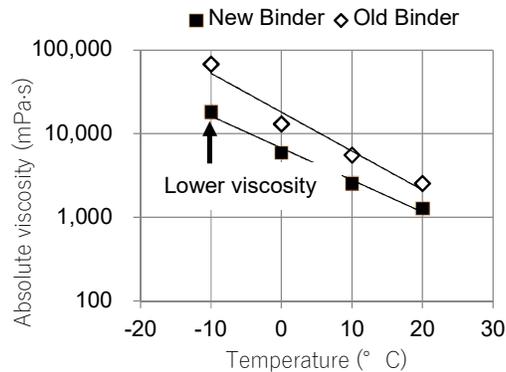
It was also found that there were other types of low-viscosity fatty acids that could be used in a low-temperature environment. As a result, a binding material which had a low melting point and low viscosity at -10°C was selected for study. Mixes composed of old and new binders were tested. The results of viscosity testing confirmed that the mix with the new binder had a lower viscosity at low temperatures compared to the old binder (Figure 3).

Figure 3: Relationship between absolute binder viscosity and temperature

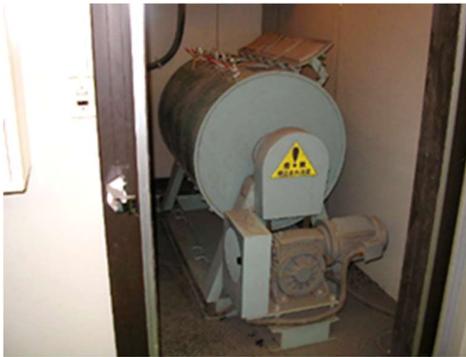
The prototype moisture-hardened mix, when mixed with the old binder, became stiff and fragile at low temperatures even if construction was carried out in optimal conditions. As a result, cellulose fibre was chosen as the additive to improve its strength. A range of fibres were selected for study. Each of them was added to the mix and then subject to Cantabro loss rate testing at -10°C . The Cantabro test machine, and the test samples after testing, are shown in Figure 4 and Figure 5 respectively.

Figure 4: Los Angeles (Cantabro) machine

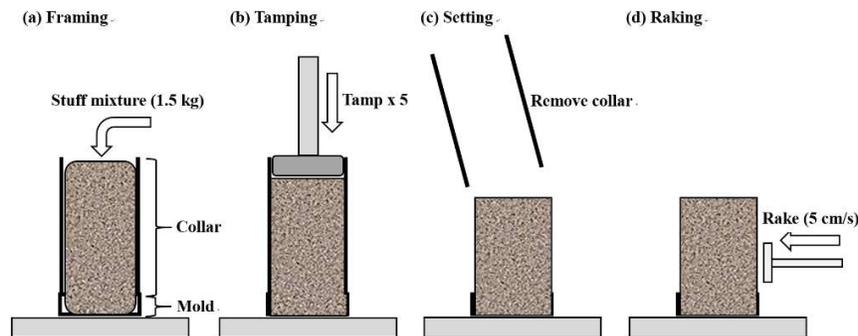
The moisture-hardened cold-mix asphalt, which had a high durability at 20°C, was examined using the Raking Workability Test (Gento, Murai & Kakinuma 2017). The procedure, using a modelled rake, is shown in Figure 8 and Figure 9.

Figure 8: Raking Workability test procedure

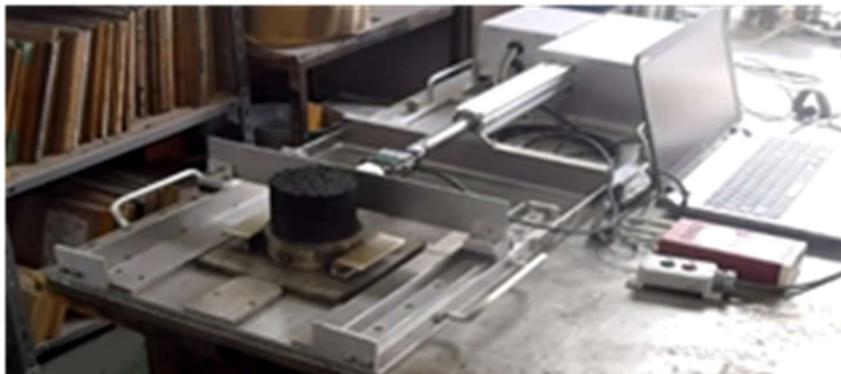
Figure 9: Raking Workability test machine

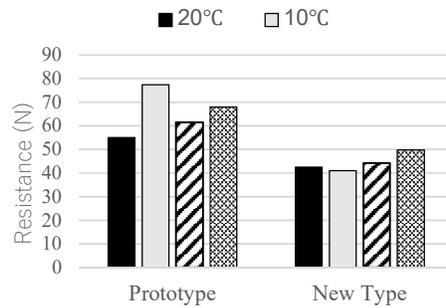
Testing was conducted at four different temperatures. For all temperature ranges, the moisture-hardened mix had a lower maximum load than the prototype mix, meaning that the newly-developed mix had excellent workability (Figure 10).

Figure 10: Comparison of maximum load: Ranking test

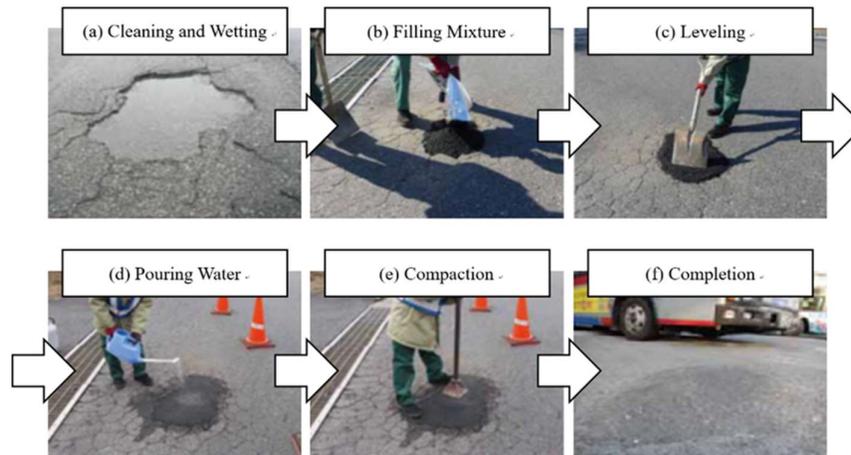
The construction procedure for the newly-developed mix is generally the same as for conventional cold mixes. However, the new mix needs 1 Litre of water to be added for every 20 kg of the mix because of its hardening mechanism (Figure 12). It is usually compacted by a tamper but foot stamping is possible.

Figure 12: Construction of pavement with new mix

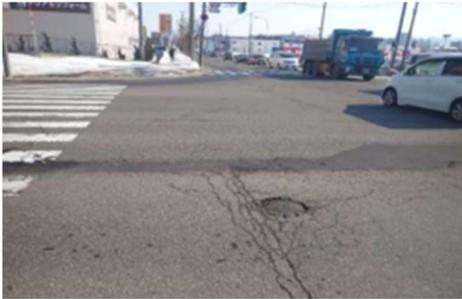
Although the temperature was near 0°C on that day, the cold mix did not have any lumps and the workability was good. There was no further pavement distress after two months and the mix continued to perform well until full-scale repair work was conducted one year later.

Figure 13: Intersection 2 months after construction

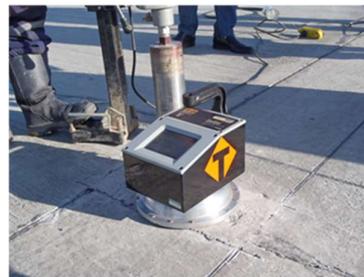
Figure 19: Density measurement using electromagnetic wave

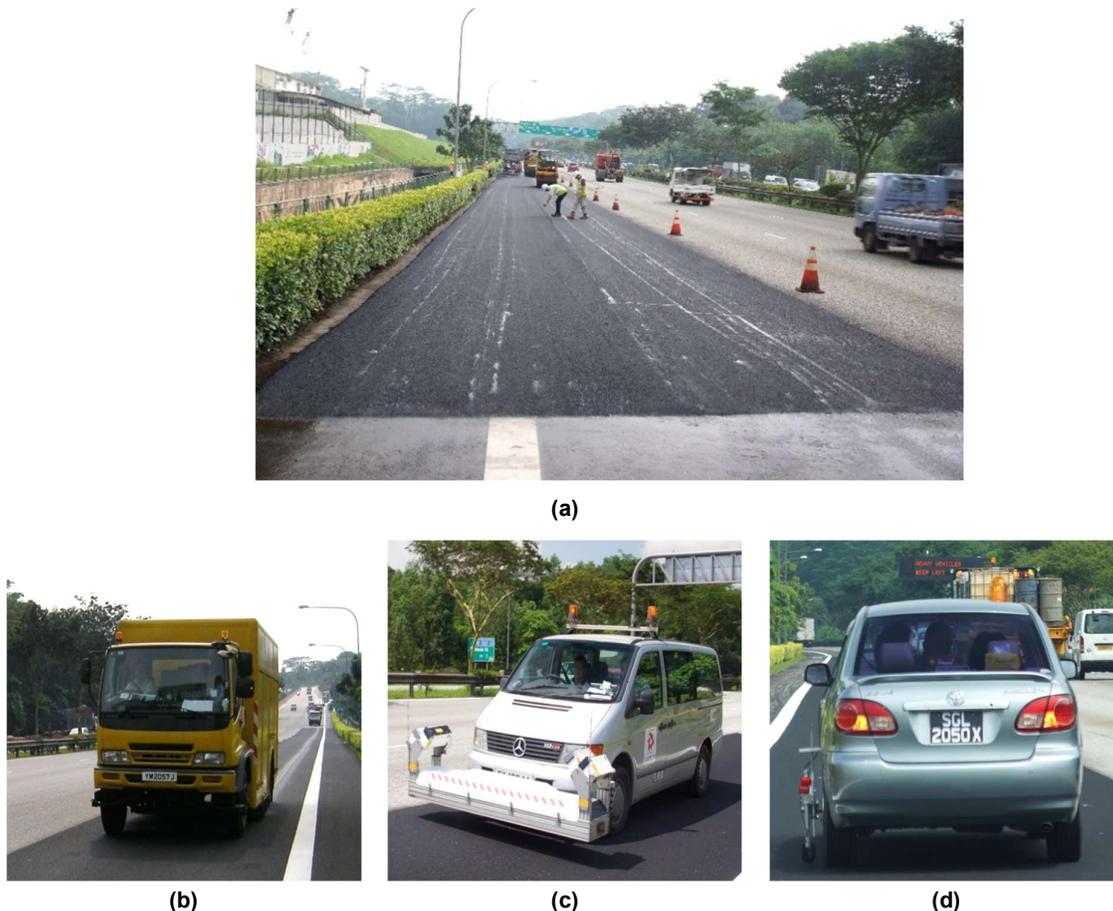
Laboratory testing and field performance monitoring was conducted to assess the effectiveness of the steel slag porous asphalt compared to the older version, as well as another type of asphalt mix commonly used for expressways. The steel slag porous asphalt mix, along with the control asphalt mixes, were paved along the Kranji Expressway (KJE) for performance monitoring in 2012. The field trial and the testing methods employed for performance monitoring purposes is shown in Figure 2.

Figure 2: Trial of steel slag porous asphalt along KJE:

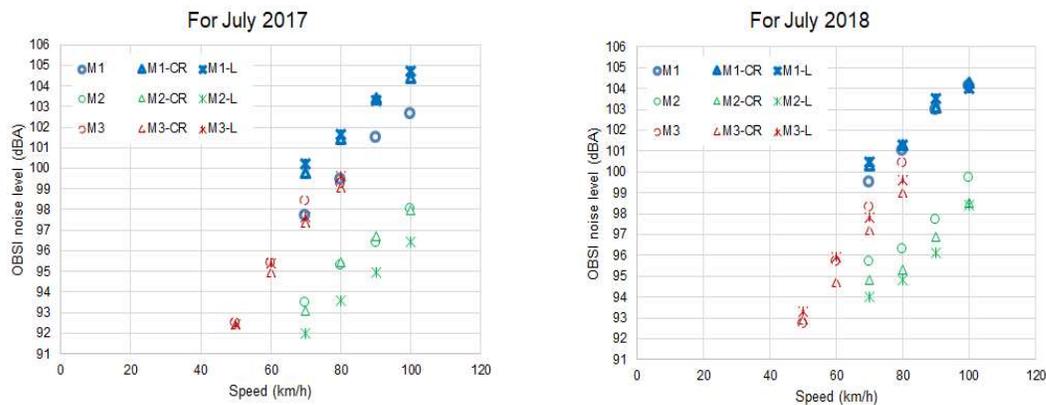
However, as demonstrated in Figure 3, the addition of the rubbers had limited influence in terms of improving acoustic performance. Instead, the main parameters contributing to the lower tyre-pavement noise were the inherent design features of the M2 mix, including the interconnecting air voids and a smaller surface texture. Notably, the M2 mix generated approximately 5 dBA lower tyre-pavement noise compared to the M1 mix at each measured speed.

Figure 3: Tyre pavement noise monitoring for three different mixes: (a) data collected in 2017; (b) data collected in 2018

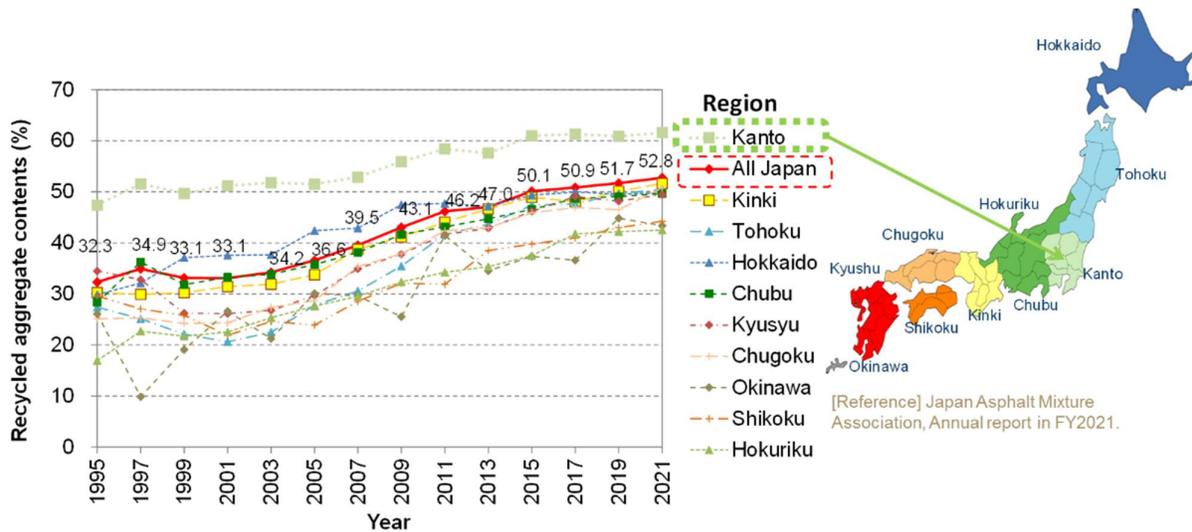
However, and as illustrated in Figure 2, there is a concern about the high usages of reclaimed asphalt pavement materials (RAP), not only in the Kanto region, which includes Tokyo, and also neighbouring areas, which are all using pavements with high RAP contents. This poses a question regarding the effects of rejuvenators in bitumen, which are used in repeated recycling under various compositions that have not yet been clarified.

Figure 2: RAP contents in the recycled mix (Japan Asphalt Mixture Association, Annual report in FY2022)

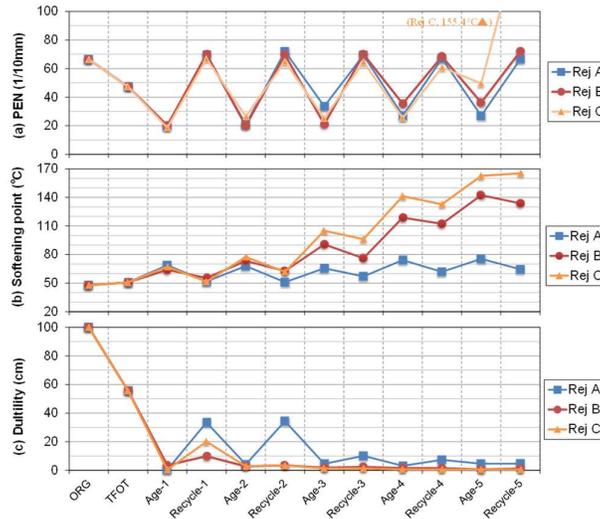
In conclusion, the softening point increased and the ductility decreased. This indicates that recycled bitumen might become stiff and brittle at high temperatures after repeated aging and recycling. These properties were more pronounced for rejuvenators with higher saturated content than aromatics.

Figure 4: Test results of needle penetration (a), softening point (b), and ductility (c)

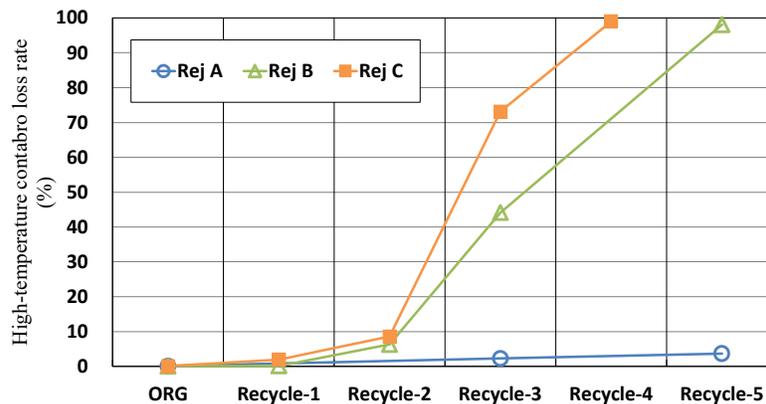
In conclusion, the adhesive strength of recycled bitumen at high temperatures became weak when the number of times of recycling was too high and when rejuvenators having a high saturated content were used. This is significant, because, if tensile strain near the tyre edge in the low-stiffness condition in midsummer relates to the cause of top-down cracking (Nishizawa et al. 1993), then a mix with a higher HCLR value may be susceptible to top-down cracking.

Figure 6: Results of high-temperature Contabro loss rate testing

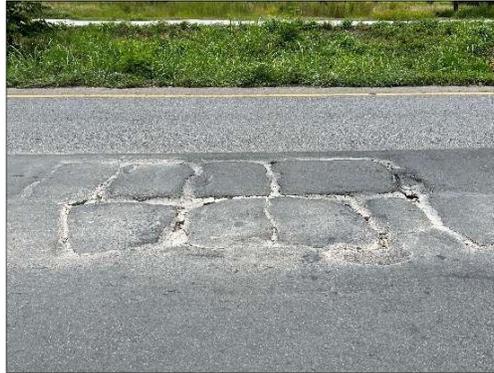
Figure 1: Example of block cracking along National Highway No. 117

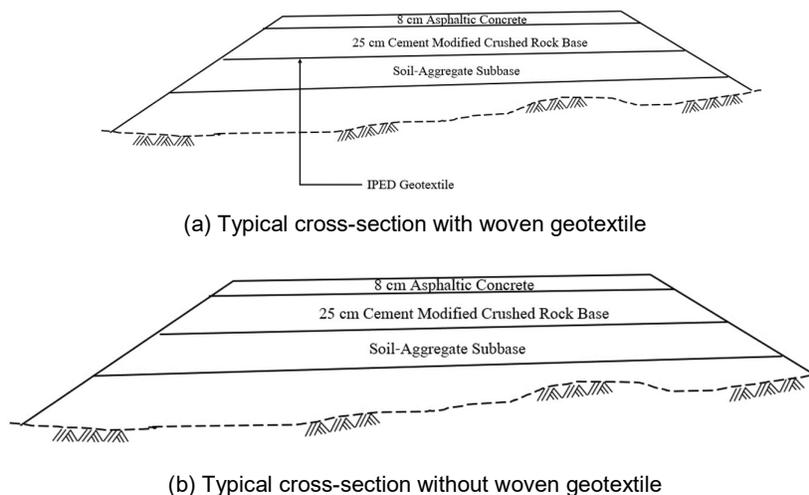
Based on the available traffic information, the expected number of equivalent standard axle loads (ESALs) for a 15-year design period was 10 million. According to the AASHTO (1993) design procedures, the required minimum structural number (SN) was 6.4. Therefore, a proposed pavement structure consisting of 80 mm an asphalt surface, 250 mm of cement-modified crushed rock base, 300 mm of soil-aggregate subbase, and 200 mm of selected material was acceptable. In addition to this proposed semi-rigid pavement (SN ~ 6.6), a woven geotextile (TenCate Mirafi® H2Rx) was also included to provide additional reinforcement and lateral drainage, and to separate new stabilized layers and the existing underlying layers. The typical cross-section of the proposed road, with and without the woven geotextile, is shown in Figure 2.

Figure 2: Cross-section of proposed four-lane divided road

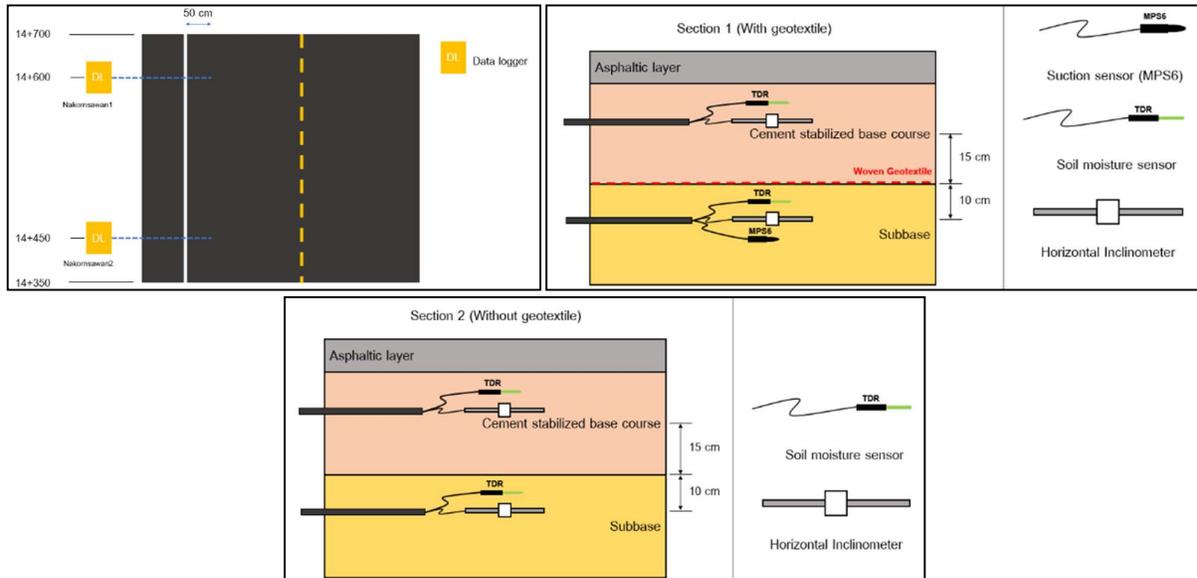
A field trial, 1 km long, was established for detailed investigation. This trial site was divided into two 500 m long sections, one with geosynthetic reinforcement and one without geosynthetic reinforcement. The project was conducted over 30 days between 22 September and 23 October 2022. Field instrumentation, e.g. horizontal inclinometer, moisture sensors, suction sensors, a rain gauge, data logger, etc. was installed in the sections in order to compare their in-service performance under the prevailing traffic loading and climatic conditions. The layout of field monitoring instrumentation is shown in Figure 3.

Figure 3: Layout of field monitoring instrumentation

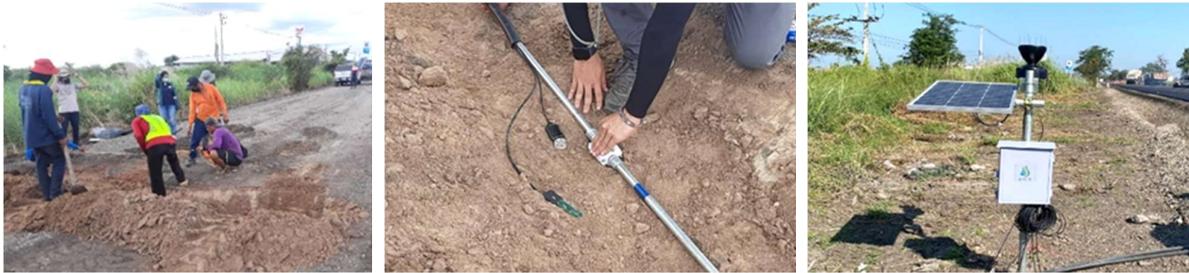
The existing asphalt surface and basecourse, a thickness of 400 mm, were removed by a milling machine. The soil-aggregate subbase was then placed and compacted to meet the designed thickness. The field instrumentation for pavement performance monitoring and the woven geotextile TenCate Mirafi® H2Rx for mechanical stabilization, moisture management, and layer material separation were then installed as shown in Figure 4 and Figure 5 respectively.

Figure 4: Installation of field monitoring instrument

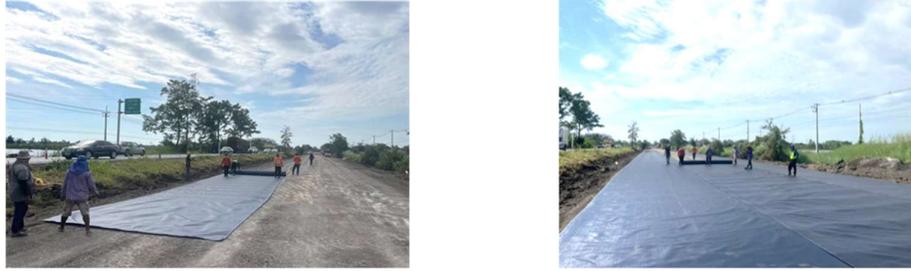
Figure 5: Installation of woven geotextile TenCate Mirafi® H2Rx

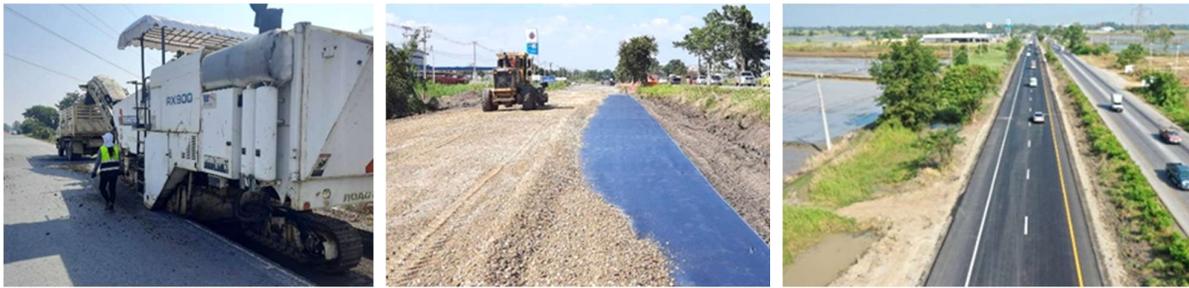
After the installation of the field monitoring instrument and the woven geotextile, a loose crushed rock layer 50 mm thick was placed for the purposes of base levelling and mixture modification. The new crushed rock and cement powder were then placed and mixed using a recycling machine to form the cement-modified crushed rock or cement-stabilized base. The target Unconfined Compressive Strength (UCS) of the cement-stabilized material was 2.4 MPa (DH-S 213/2000). To avoid any damage to the woven geotextile sheet, the mixing process using the recycling machine was performed on a section with no geosynthetic reinforcement. The machine was then hauled to a section which included the geosynthetic reinforcement. The mix was uniformly compacted to achieve the design thickness of 250 mm and the target compaction level of at least 95% of modified Proctor density. A sample of the mix was collected during the construction and subsequently compacted for laboratory UCS testing in accordance with DH-T 105/1972. After the compaction levels of both the cement-modified crushed rock base sections had been met, a prime coat was applied and the asphalt surface was placed. Photos of the construction process are shown in Figure 6.

Figure 6: Construction process

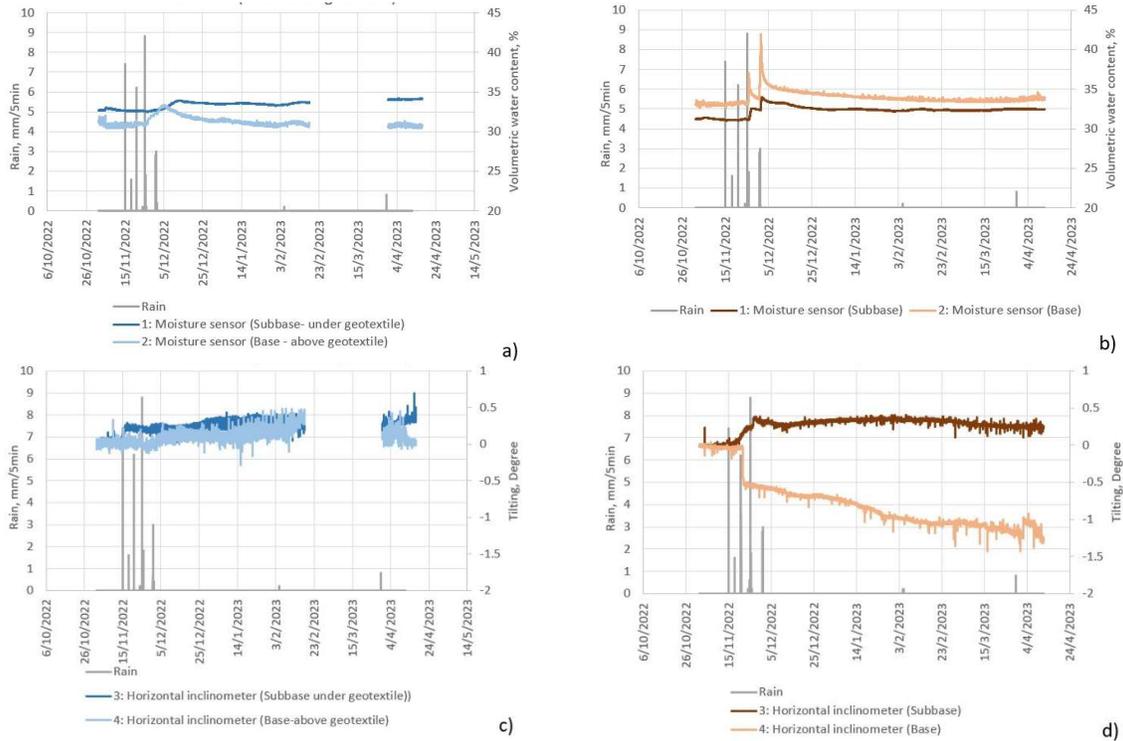
Field data was collected for the purpose of in-service performance evaluation as shown in Figure. The moisture content of the subbase layer in Section 1 (with woven geotextile, Figurea) was relatively constant regardless of the rainfall, while the moisture contents of both the subbase and base layers in Section 2 (without woven geotextile, Figureb) exhibited an abrupt change approximately 1-2 days after each rainfall event. The moisture content of the base in Section 1 only slightly increased by 1% following the rainfall. The horizontal inclinometer data also indicated consistent response. Larger movement was observed in Section 2 (without woven geotextile, Figure 8), while the movement in Section 1 (with woven geotextile, Figure) was much smaller during the rainfall event.

Figure 8: In-service performance evaluation using field monitoring data

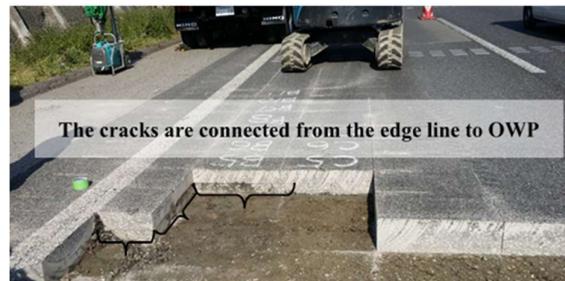
Figure 3: Horizontal cracks developed between binder course and upper basecourse

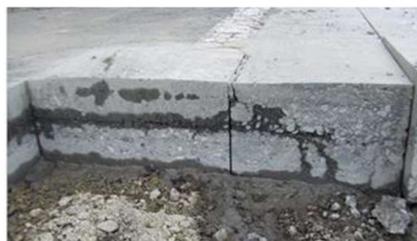
Figure 4: Rainwater penetrated into pavement through a crack

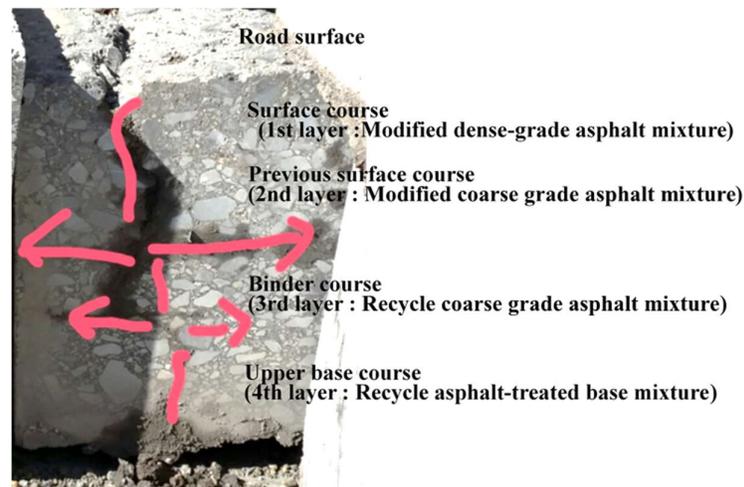
Figure 5: Progress of crack formation and horizontal cracks

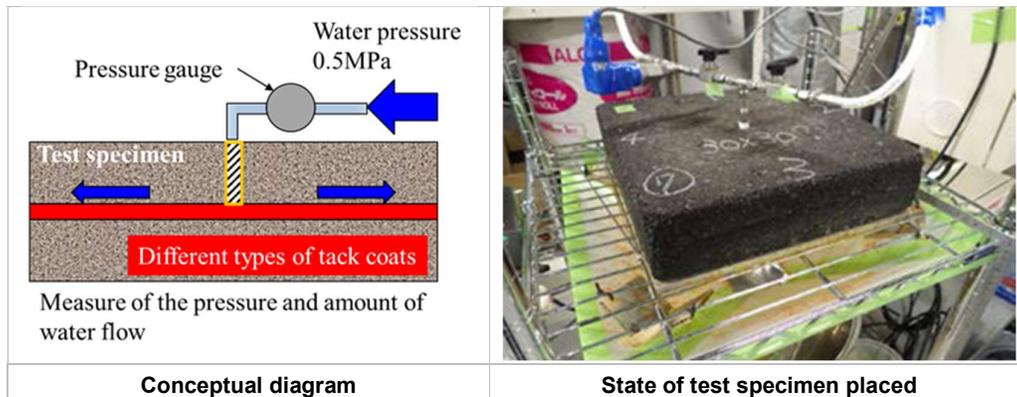
Figure 7: Set up of test specimens

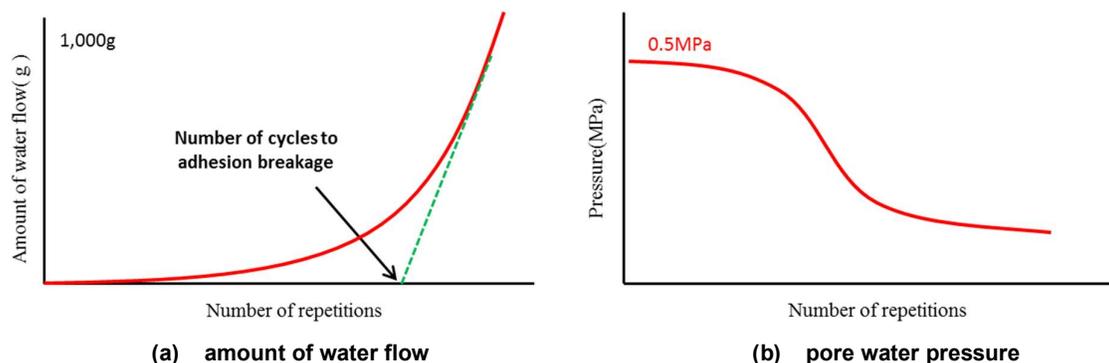
Figure 9: Relationship between number of repetitions and amount of water and pore water pressure

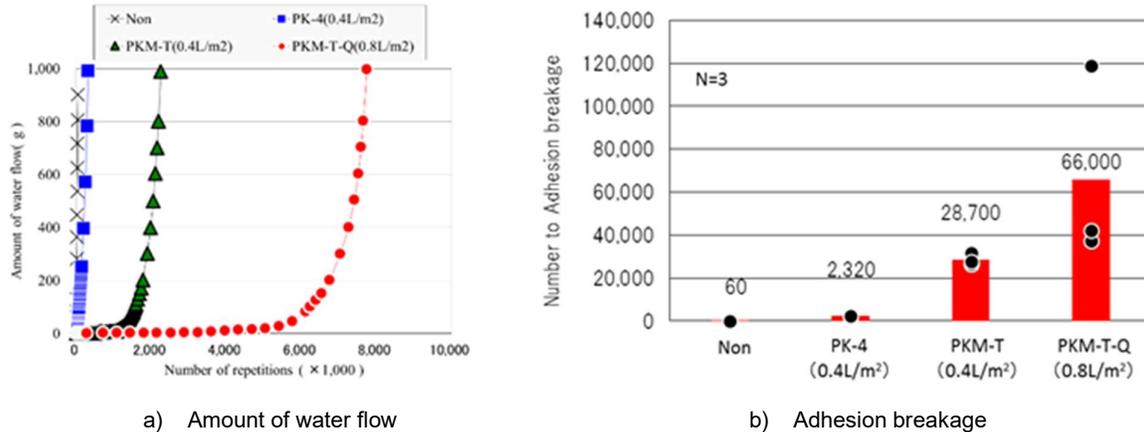
Figure 10: Relationship between the number of repetitions and:
(a) amount of water flow, and (b) adhesion breakage

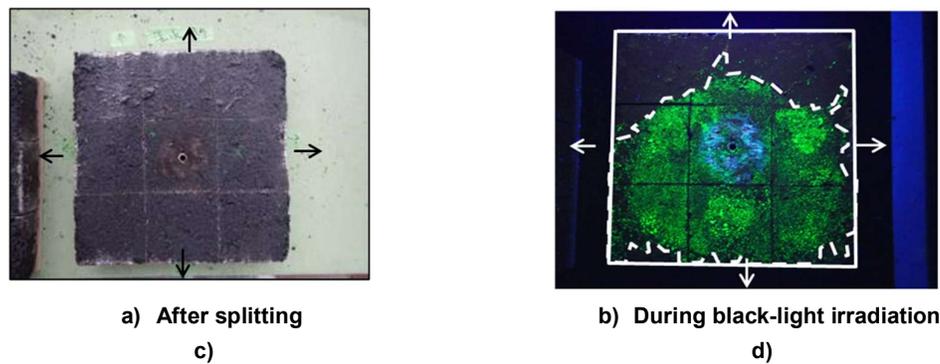
Figure 12: Results from review of water flow path (PK-4; 0.4 L/m²)

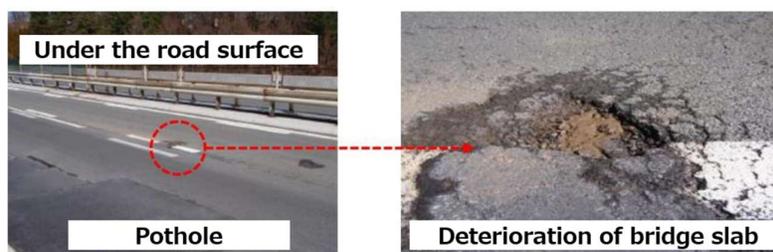
Figure 4: Examples of pavement damage caused by concrete slab deterioration

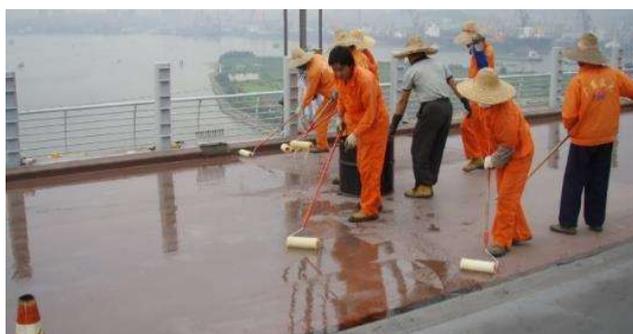
Figure 5: Overseas practice – using steel deck adhesive and epoxy-based material

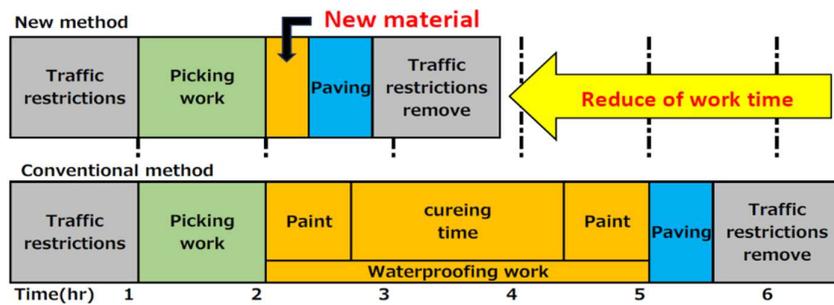
Figure 6: Comparison of work times between new method and conventional methods

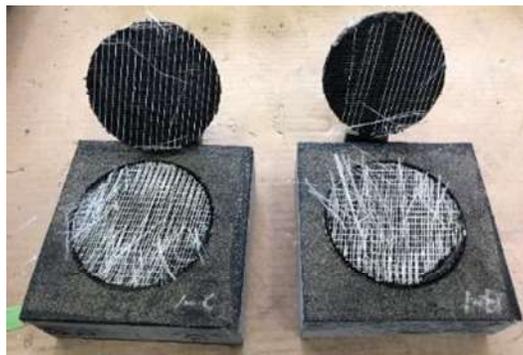
Figure 8: Bond verification test of waterproof sheets and deck slabs

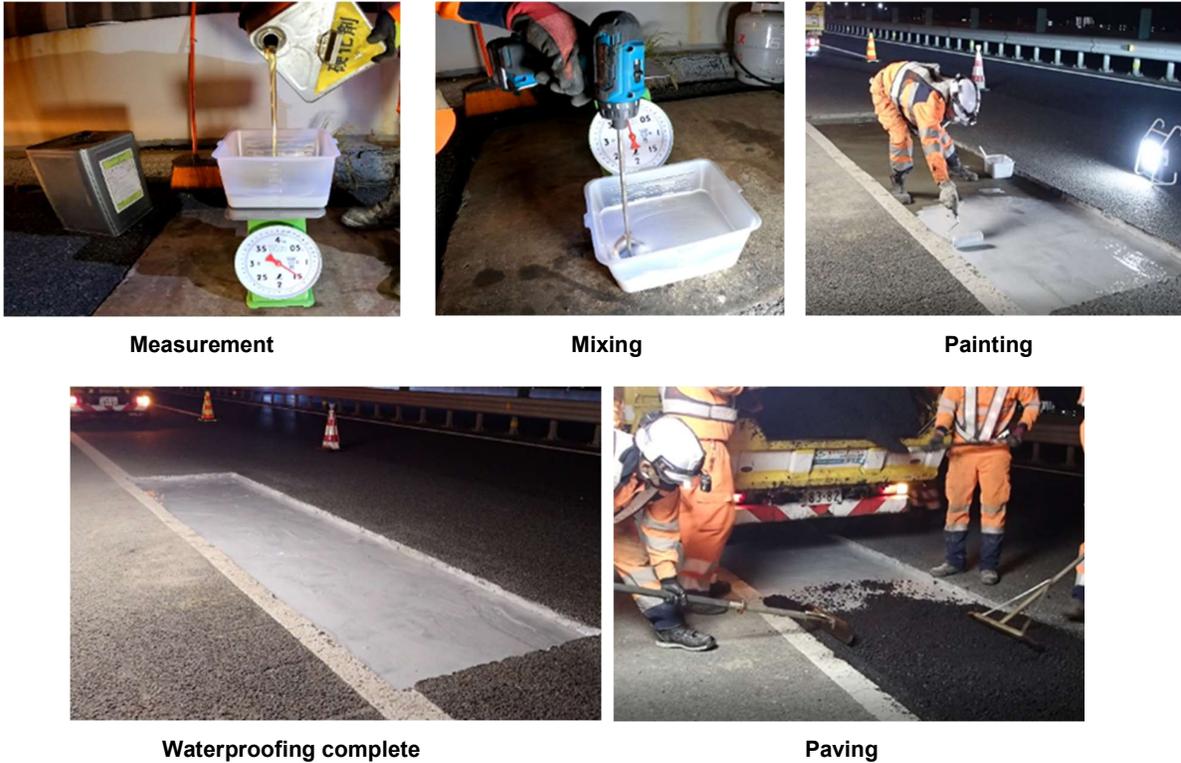
Figure 9: Construction procedure

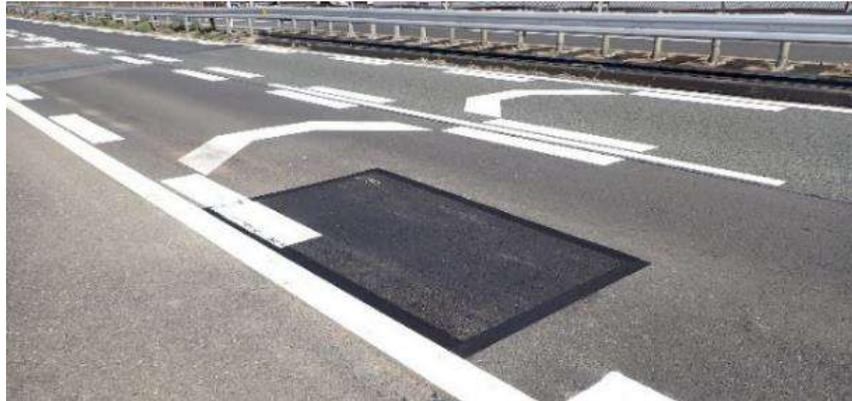
Figure 10: Appearance 60 days after repair work

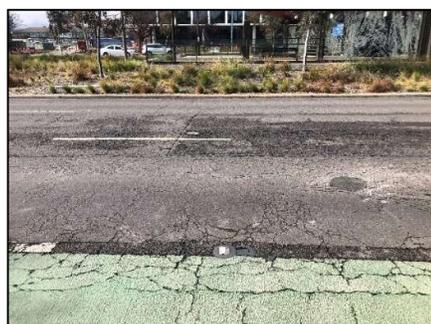
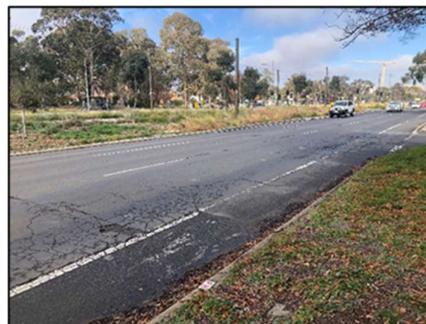
Figure 1: Typical pavement failures in Northbourne Avenue

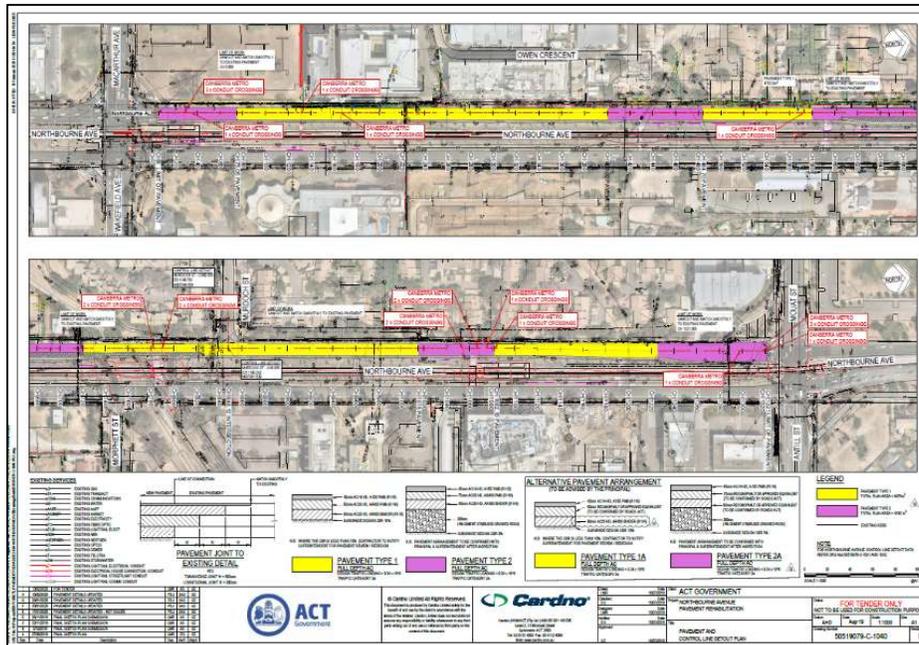
Figure 2: Preliminary project pavement designs for Northbourne Avenue rehabilitation

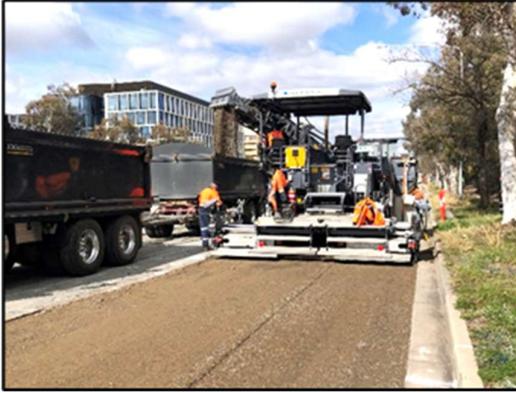
Figure 3: Example of foamed asphalt combining foamed bitumen treatment with an asphalt paver-laid process

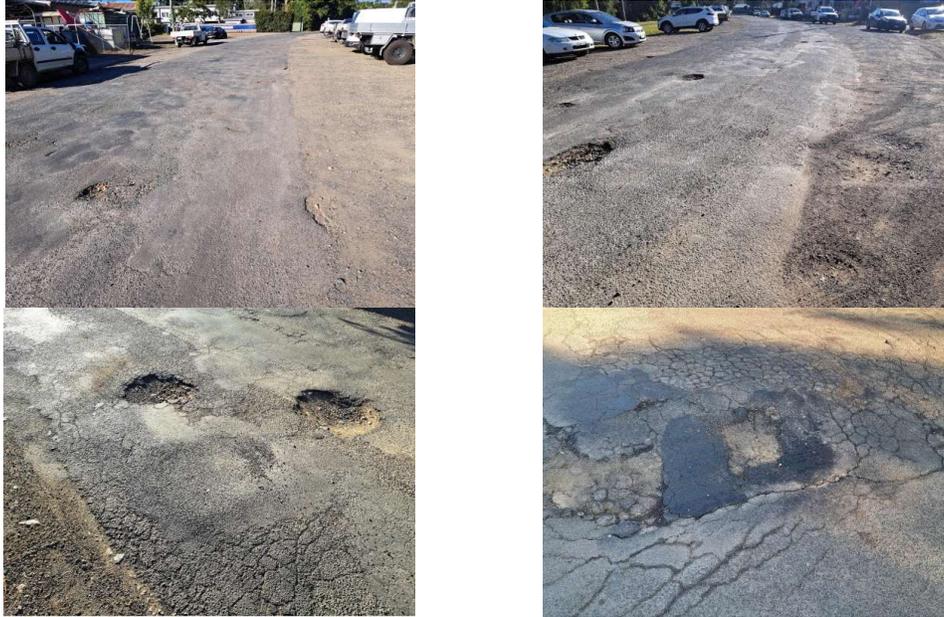
Figure 5: Condition of River Terrace pavement

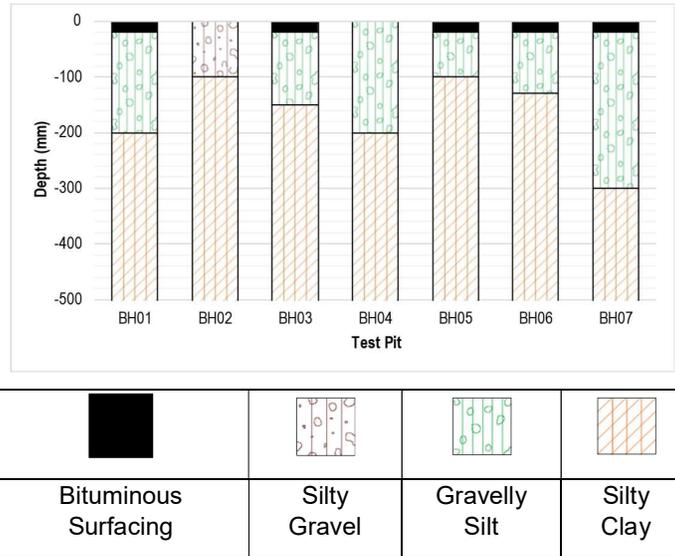
Figure 8: Existing pavement profile

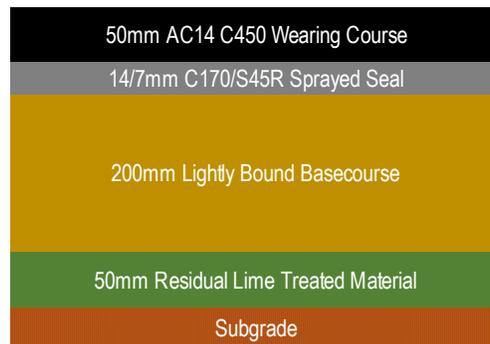
Figure 10: Pavement design cross section

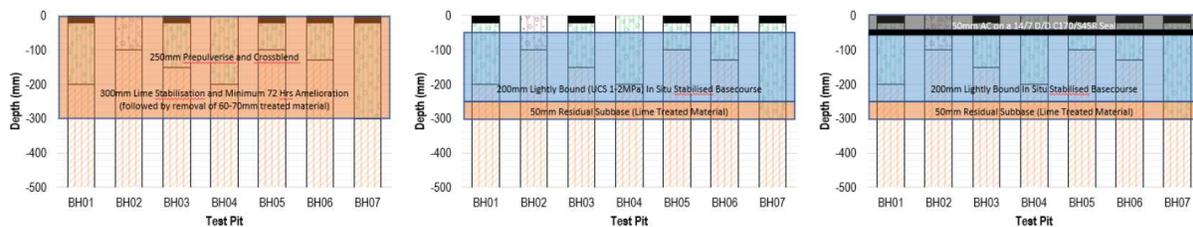
Figure 11: Construction process

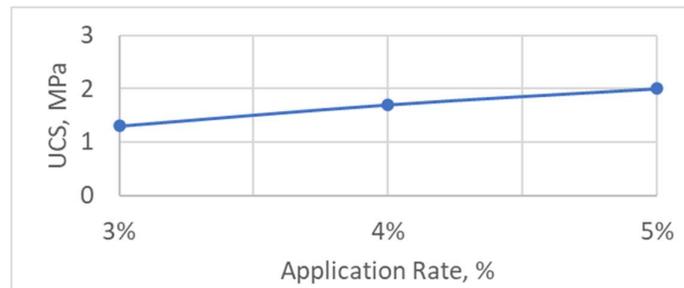
Figure 12: Trial Mix Design UCS Results

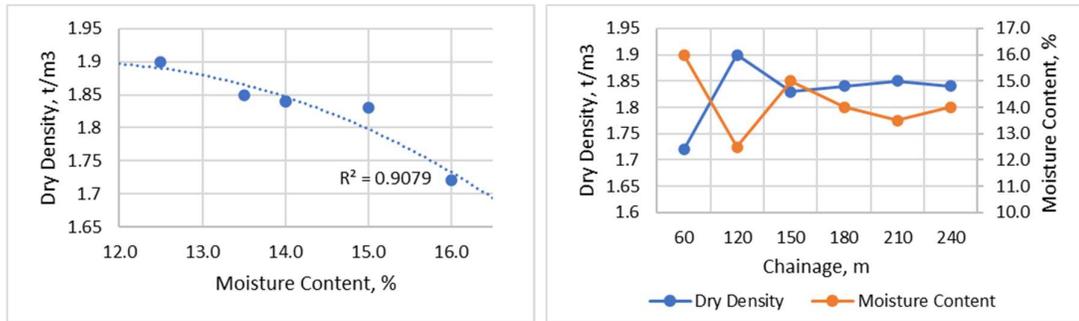
Figure 15: Dry density v moisture content post-lime stabilisation

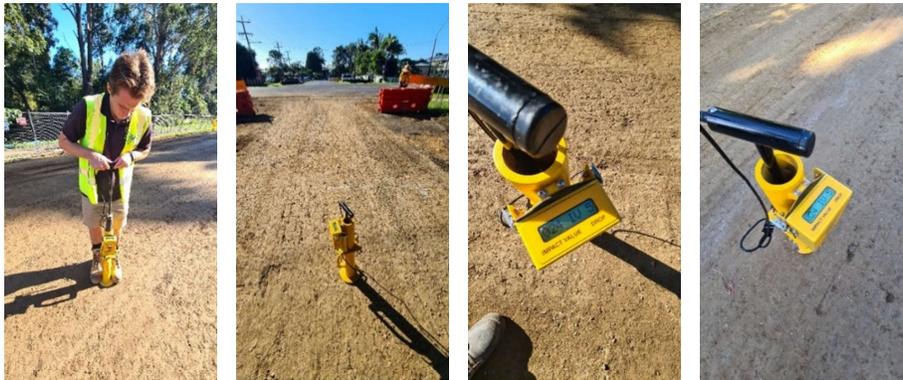
Figure 16: Clegg Hammer testing
