Compendium on Pavement Maintenance and Rehabilitation Practices

REAAA Technical Report TC-13

REAAA Project: QA of Pavement Structures

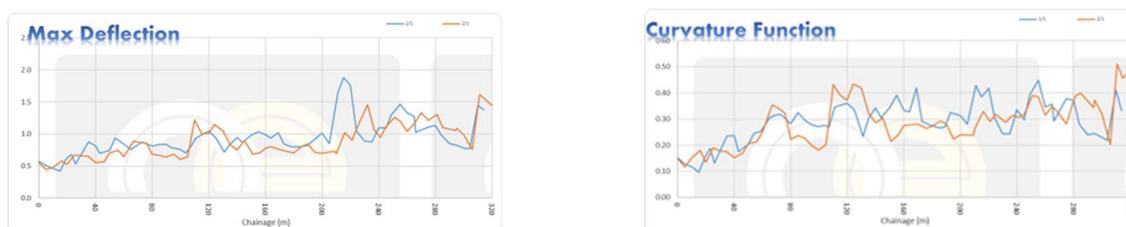
Figure 18: Maximum Deflection and curvature results
